Subject: Annual Inspection Report
NorthEast Alabama Regional Airport

ANNUAL INSPECTION REPORT

NORTHEAST ALABAMA REGIONAL
AIRPORT
GADSDEN, ALABAMA

July 27, 2011

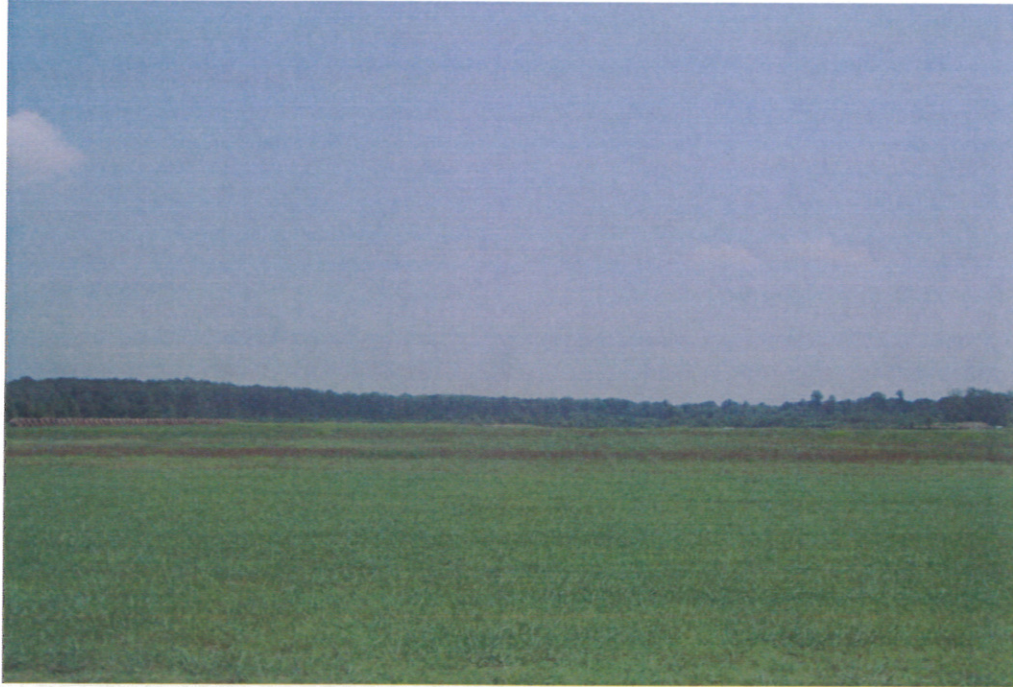
Photo 1

- ➔ The Approach/Departure Paths for Runway 6/24 are unobstructed.
- ➔ The Approach/Departure Paths for Runway 18/36 are unobstructed.

Approach to Runway 24

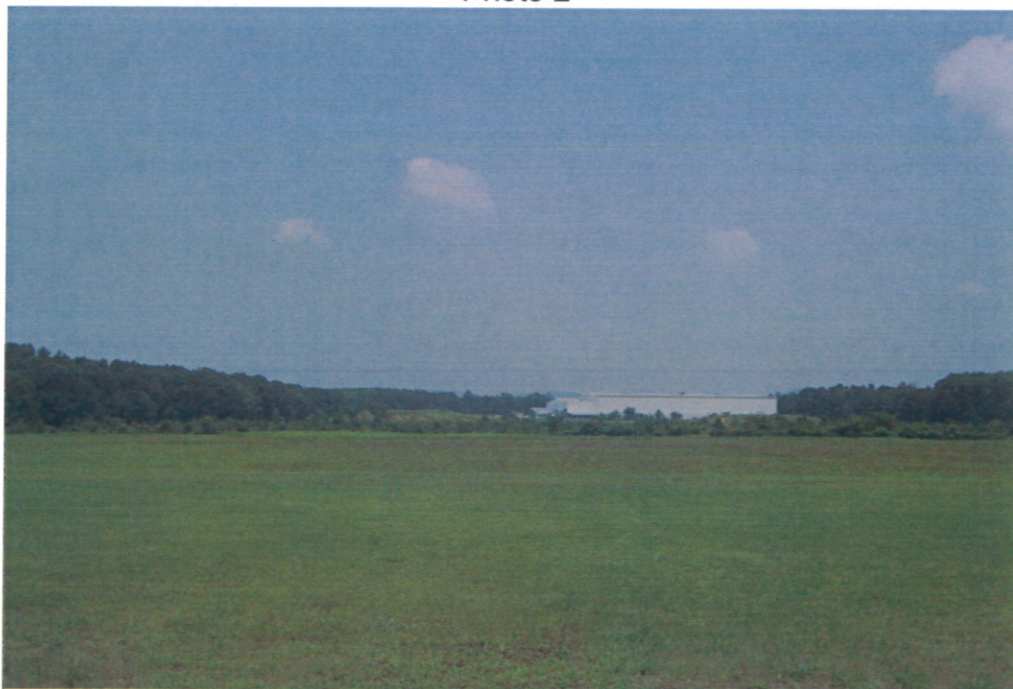
Photo 2

Approach to Runway 18

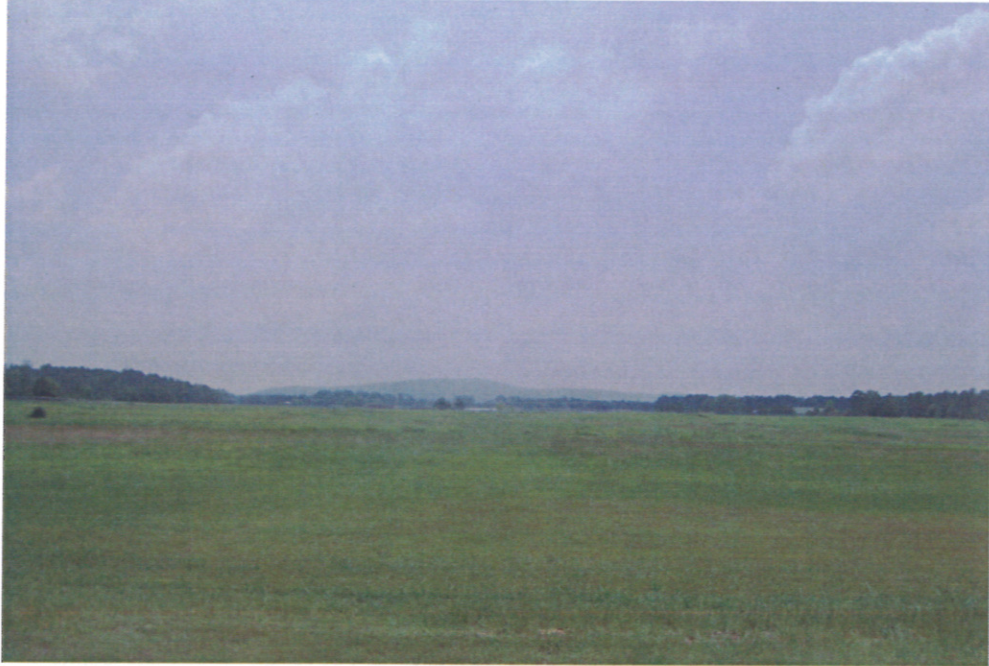
Photo 3

Approach to Runway 36

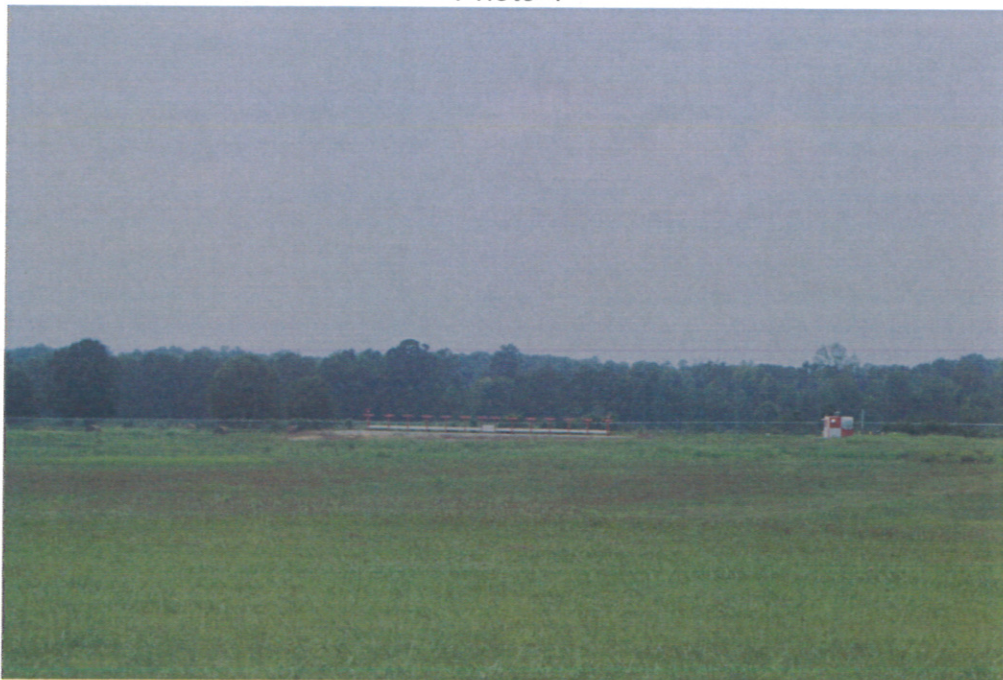
Photo 4

Approach to Runway 6

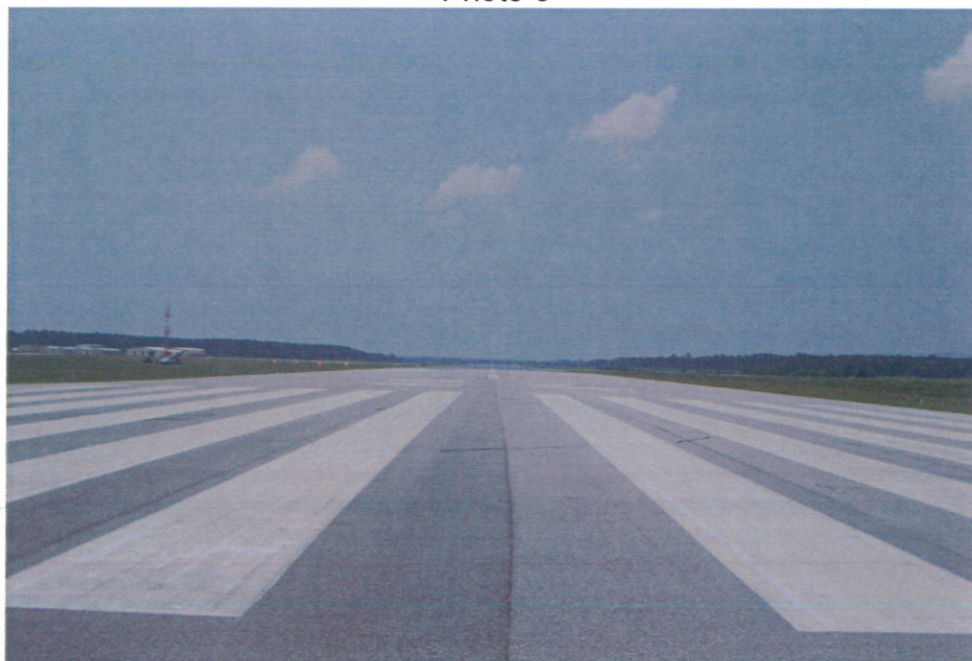
Photo 5

- Runway 6/24 – The markings are in *Good* condition.

Threshold Markings of Runway 24

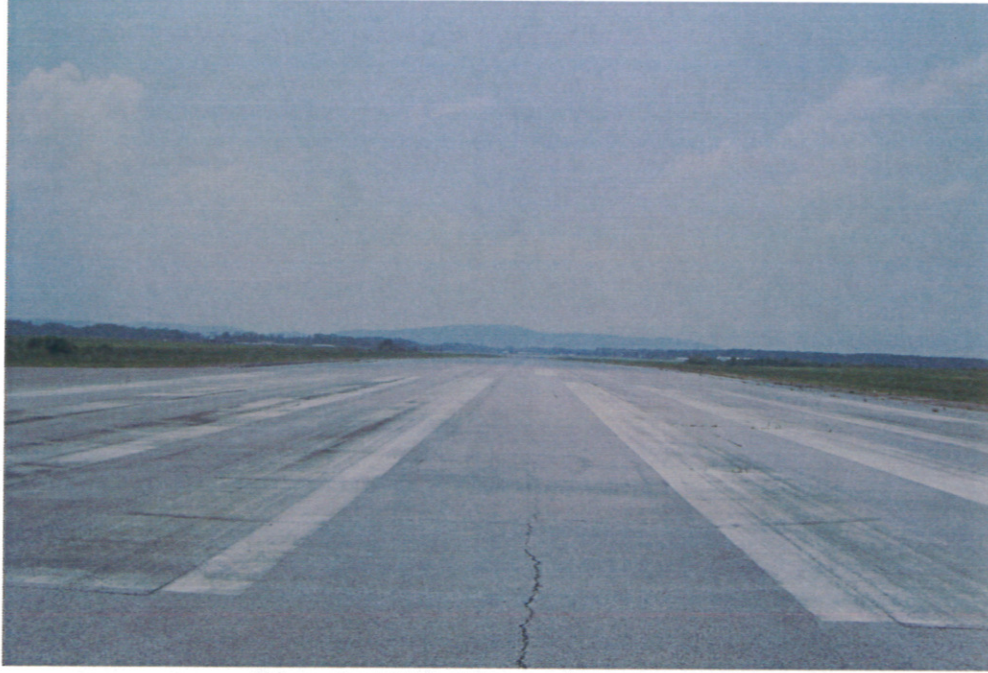
Photo 6

- Runway 18/36 – The markings are in *Poor* condition.

Threshold Markings of Runway 18

- Remark the runway in accordance with FAA AC150/5340-1K "Standards for Airport Markings".

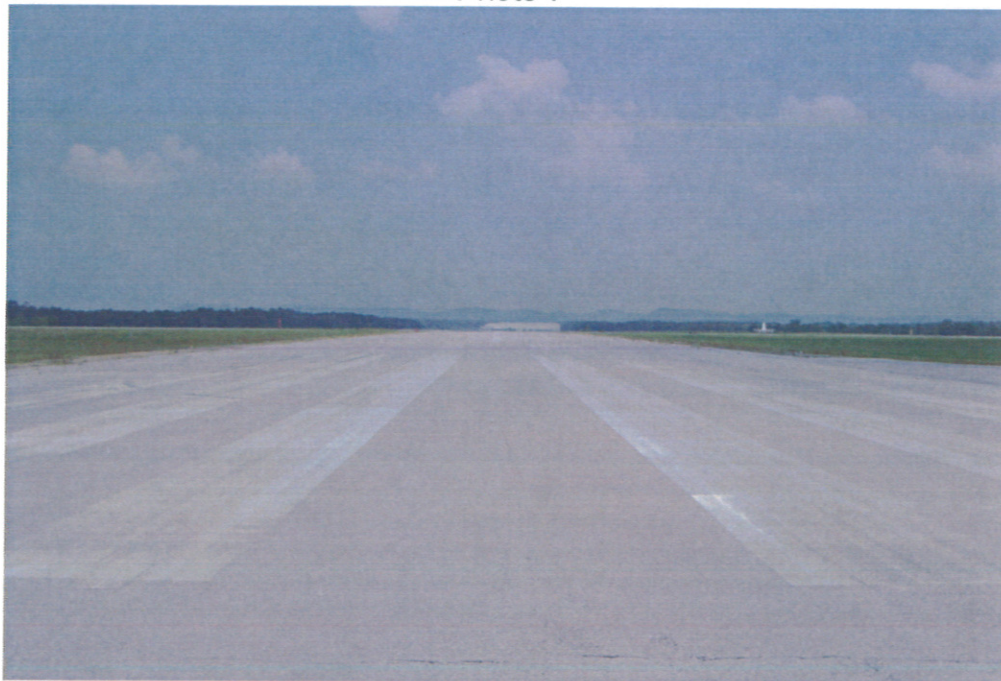
Photo 7

Threshold Markings of Runway 36

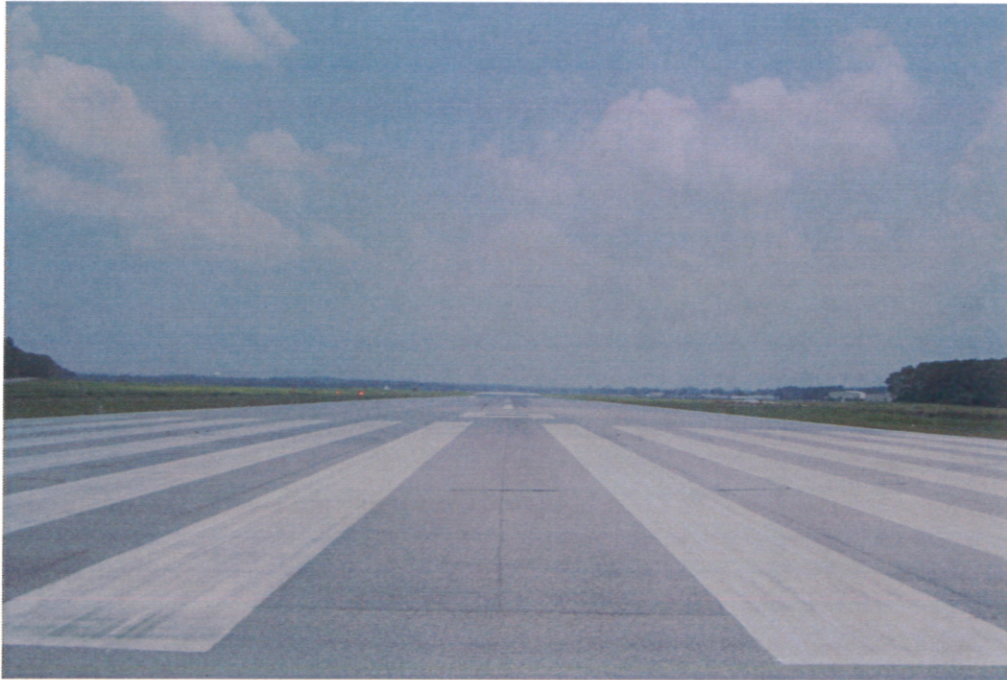
Photo 8

Approach to Runway 6

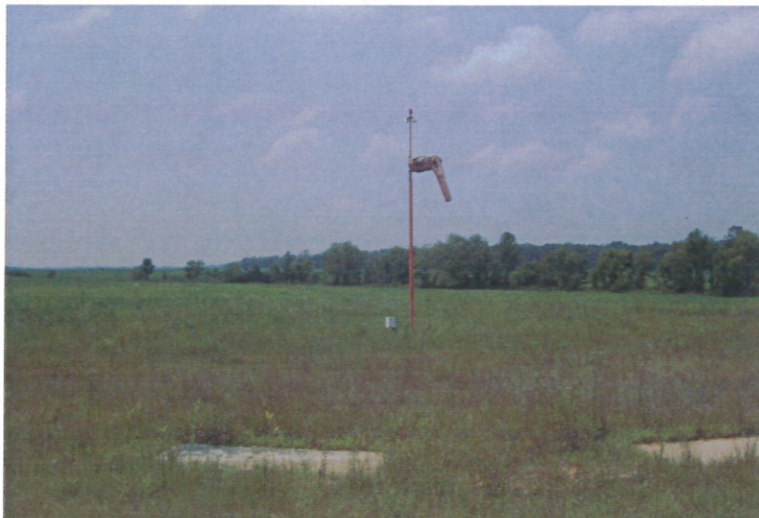
Photo 9

- The wind direction indicator was inspected and found to be lighted and operational.

Windsock assembly and segmented circle

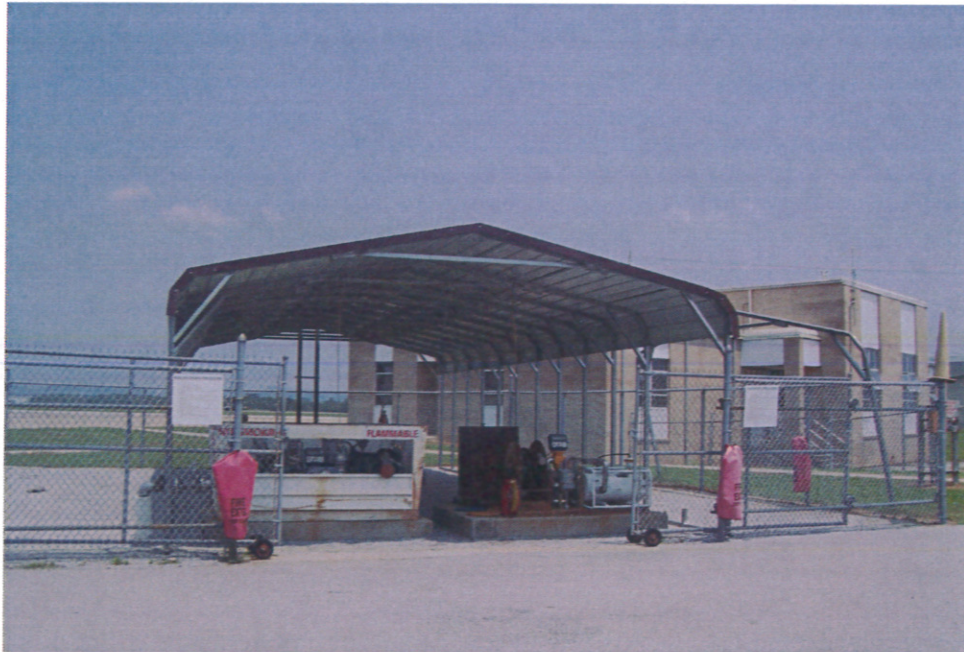
PHOTO 10

- The fueling area and trucks meet licensing requirements.
- The fueling area meets the requirements established by the Alabama Department of Transportation. However, the State of Alabama Department of Agriculture and Industries may have additional requirements for fueling systems that were not considered during this inspection.

Fueling Area
